Land Contamination

North West Cambridge – Phase 1 Development

Phase I Geo-
Environmental Desk Study
Report

NWC1-URS-ZZ-ZZZ-XX-
RPT-CE-0001

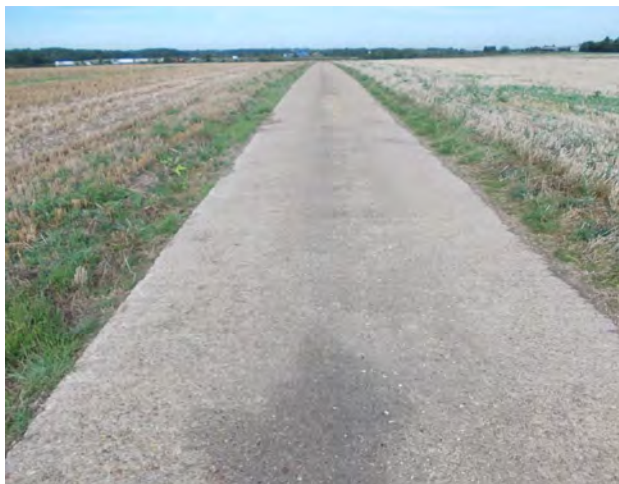
Photo 3 – Concrete track bisecting the main development area site (looking northwest)
